DEPARTMENT OF TRANSPORTATION

Quality Assurance and Source Inspection

Contract #: 04-0120F4Cty: SF/ALA Rte: 80 PM: 13.2/13.9File #: 99.28**WELDING INSPECTION REPORT****Resident Engineer:**Siegenthaler, Peter**Address:** 333 Burma Road**City:** Oakland, CA 94607**Report No:** WIR-019133**Date Inspected:** 06-Jan-2011**Project Name:** SAS Superstructure**OSM Arrival Time:** 700**Prime Contractor:** American Bridge/Fluor Enterprises, a JV**OSM Departure Time:** 1900**Contractor:** Zhenhua Port Machinery Company, Ltd (ZPMC)**Location:** Shanghai, China**CWI Name:** Li Yang and Zhu Zhong Hai**CWI Present:** Yes No**Inspected CWI report:** Yes No N/A**Rod Oven in Use:** Yes No N/A**Electrode to specification:** Yes No N/A**Weld Procedures Followed:** Yes No N/A**Qualified Welders:** Yes No N/A**Verified Joint Fit-up:** Yes No N/A**Approved Drawings:** Yes No N/A**Approved WPS:** Yes No N/A**Delayed / Cancelled:** Yes No N/A**Bridge No:** 34-0006**Component:** OBG Trial Assembly**Summary of Items Observed:**

Orthotropic Box Girder (OBG) at Trial Assembly Areas

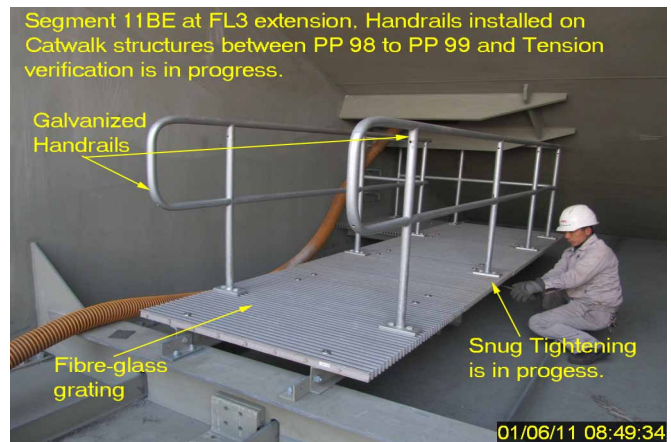
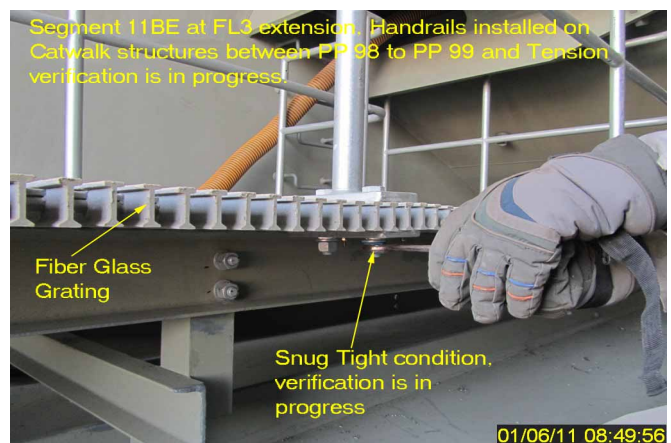
This QA Inspector witnessed the final bolt tension verification on bolts connecting the Handrail to Fiber Glass Grating between Panel Points (PP) 98 and PP 99 for Segment 11BE. Handrails are installed at FL3 extension Bottom Plate on Catwalk Structure. The QA Inspector verified the bolt tension on a random basis and the results appeared to be in general compliance. The Inspection was performed against Notification No. 00599 dated January 06, 2011.

The bolt sizes used were M16 x 95 RC Lot # DHGM160046 and the final torque value established was Snug Tight.

A spanner wrench was used to verify the snug tight condition.

Please reference the pictures attached for more comprehensive details.

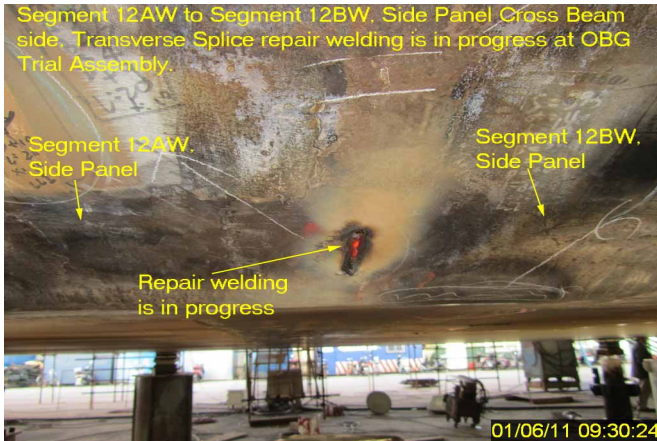
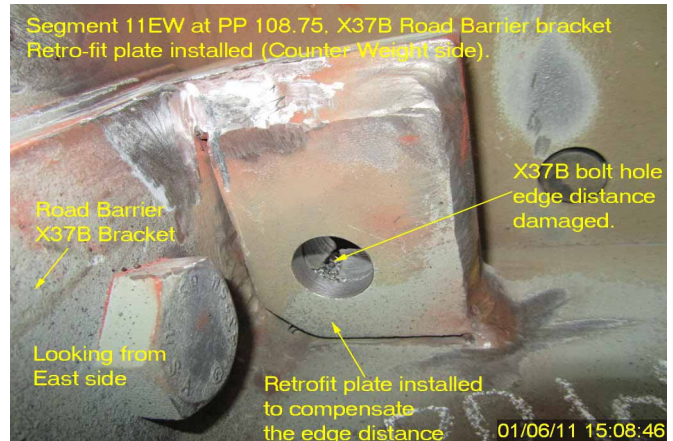
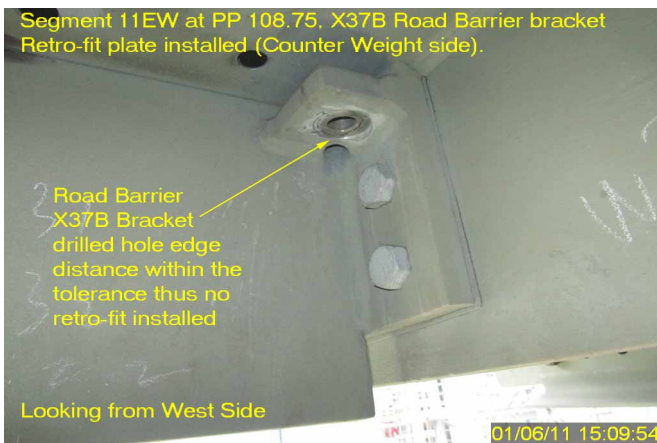
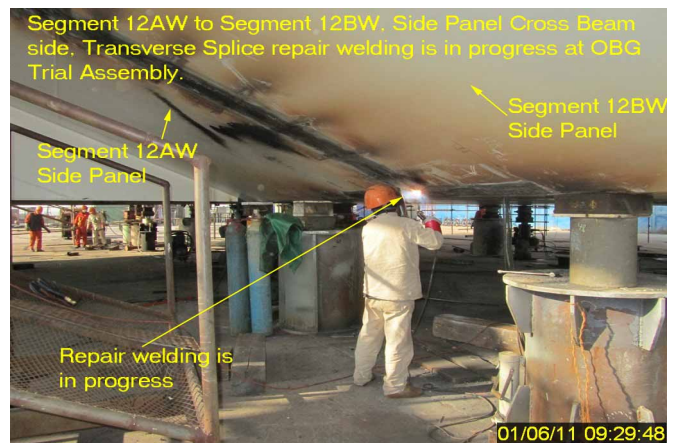
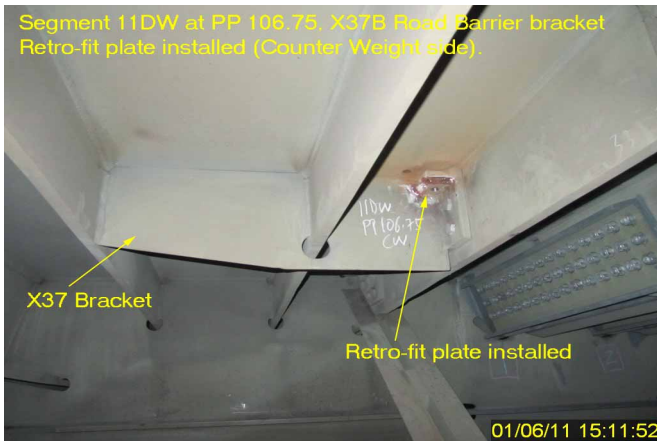
This QA Inspector observed the repair welding by Shielded Metal Arc Welding (SMAW) process on a Complete Joint Penetration (CJP) groove weld. The Weld joint was designated as OBE12D-002. The welder identification was 046709 and observed welding in the 4G (Overhead) position using approved Welding Procedure Specification WPS-345-SMAW-4G(4F)-FCM-Repair-1. The piece mark was identified as the Side Panel, at transverse splice. ZPMC performed repair welding in accordance with Critical Welding Repair Report B-CWR2709 dated January 7, 2011.

This QA Inspector observed the in-process welding by Flux Cored Arc Welding (FCAW) process on a Complete Joint Penetration (CJP) groove weld. The Weld joint was designated as OBE12C-001. The welder identification was 040458 and 047353 and observed welding in the 1G (Flat) position using approved Welding Procedure Specification WPS-B-T-2231T-ESAB. The piece mark was identified as the Bottom Panel, at transverse splice.

Please reference the pictures attached for more comprehensive details.
